March 2015

Main Water System

TEST RESULTS BY WATER QUALITY ZONE

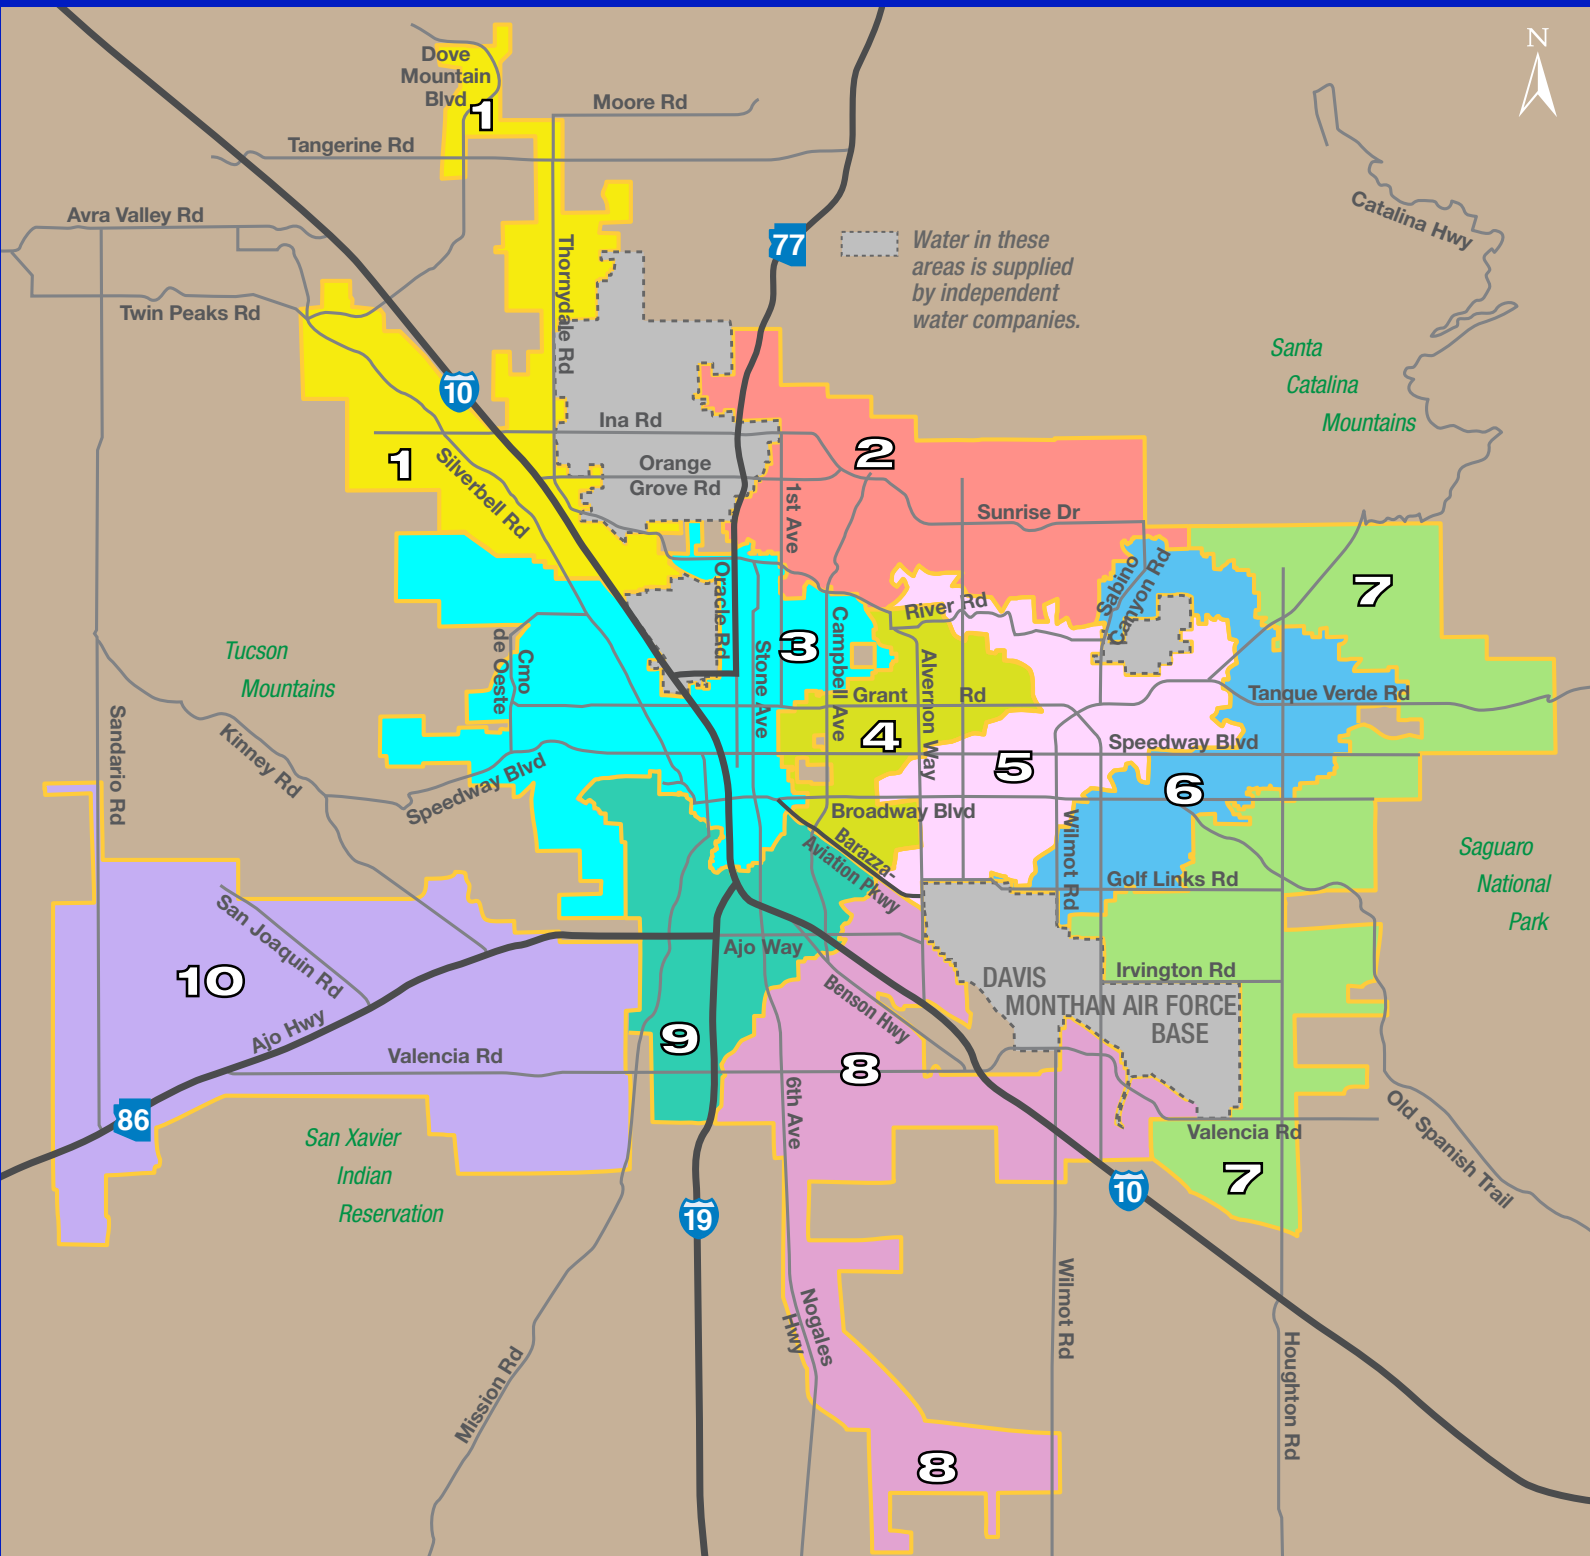
To ensure your tap water is safe, clean and secure, Tucson Water conducts approximately 14,500 individual tests each year on the water in the main distribution system – before it reaches your home. Test results for key parameters are reported by 10 water quality zones for a water distribution system that covers some 375 square miles.

Zones	Hardness (mg/L*) 55 SP	Sodium (mg/L*) 53 SP	Nitrate-N (mg/L*) 86 SP	Fluoride (mg/L*) 86 SP	pH Level (S.U.) 247 SP	Temperature (deg°F) 247 SP
1	239	67	1.56	0.43	7.9	74.1
2	243	69	0.94	0.37	8.0	73.5
3	233	66	1.18	0.42	8.0	73.5
4	245	69	0.83	0.35	7.9	74.1
5	239	67	0.98	0.38	8.0	72.8
6	241	68	0.91	0.36	8.0	73.2
7	241	67	1.00	0.38	8.0	73.3
8	209	57	1.97	0.60	7.8	74.1
9	219	62	1.55	0.51	7.8	75.2
10	255	72	1.17	0.37	7.9	75.1
Avg	235	66	1.18	0.42	7.9	73.7

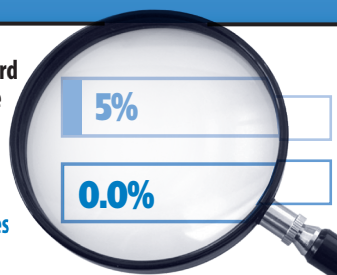
The U.S. Environmental Protection Agency (EPA) has primary standards for levels of coliform bacteria and the disinfectant chlorine.

EPA standard
for positive
samples
Positive
results
247 samples

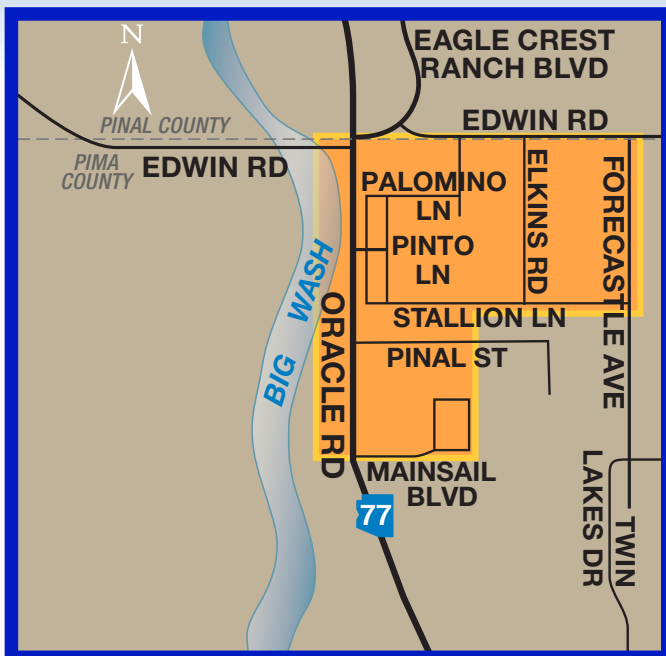
Catalina Water System

Catalina is a community partially served by Tucson Water. It has about 400 connections, supplying water to about 1,000 persons with water from two wells.

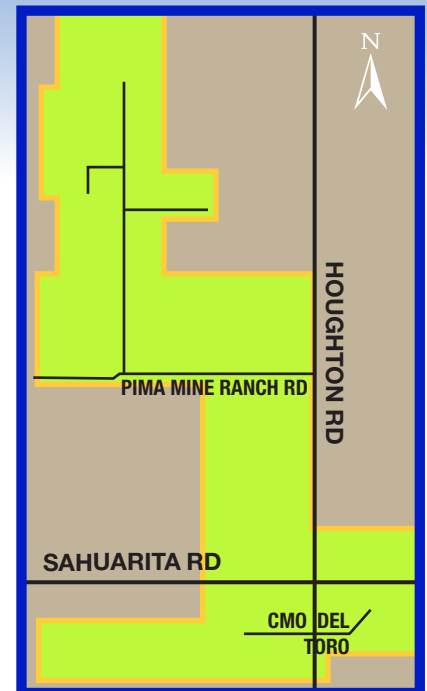
Corona de Tucson Water System

Corona de Tucson is a community located near Sahuarita and Houghton Roads, with about 2,600 connections supplying about 7,300 persons with water from three wells.

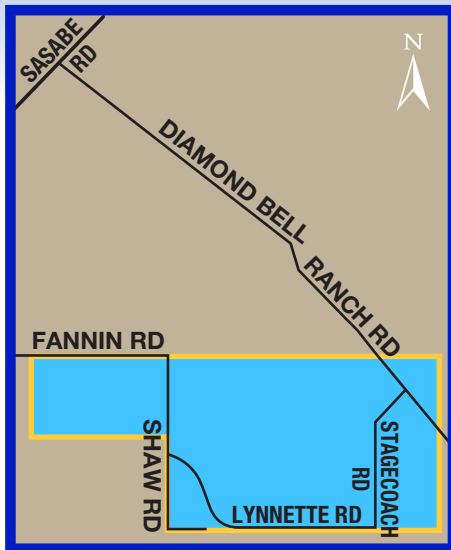
Diamond Bell Water System

Diamond Bell is a community located south and east of Sasabe Road and Diamond Bell Ranch Road respectively, with about 200 connections supplying about 570 persons with water from two wells.

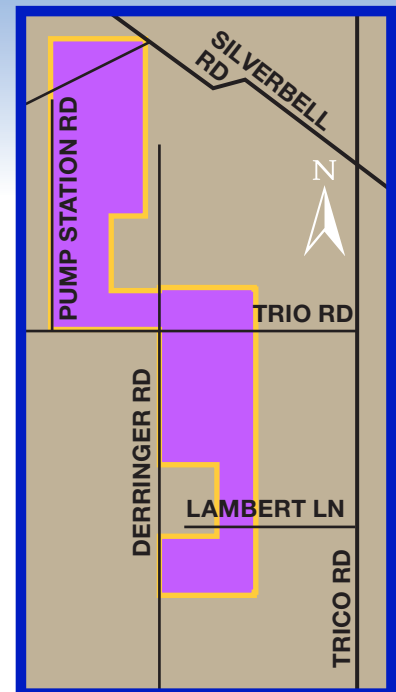
Rancho del Sol Lindo & White Fence Farms Water System

Rancho del Sol Lindo is a community located southwest of Silverbell Road and North Trico Road. Rancho del Sol Lindo has about 1,000 connections, supplying about 2,700 persons with water from two wells.

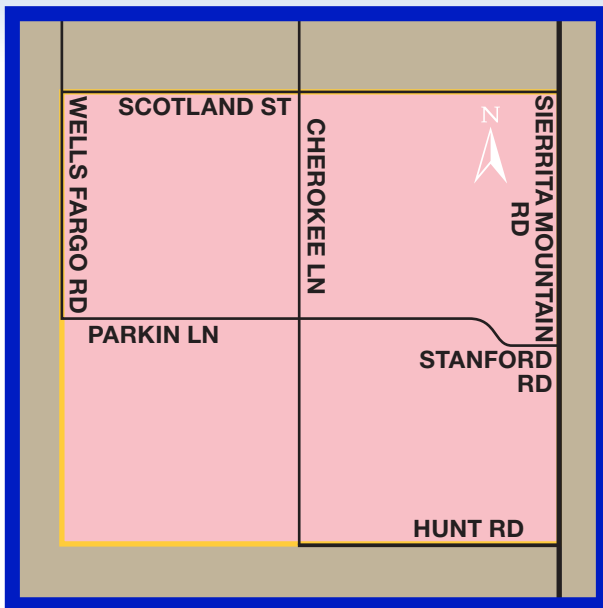
Sierrita Foothills Water System

This is a small community by the Three Points area, with 30 connections supplying approximately 75 people from one well.

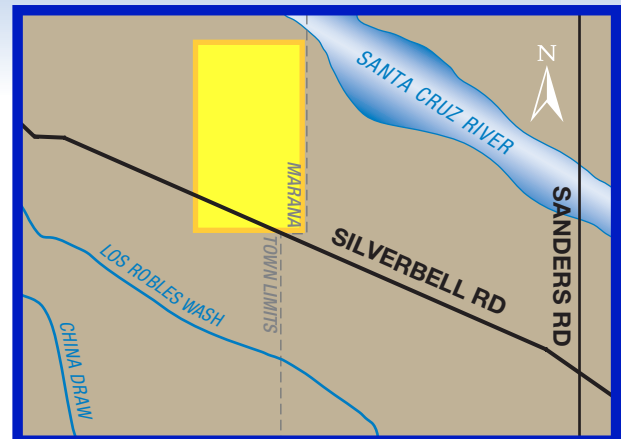
Silverbell West Water System

The Silverbell West system has 83 connections serving approximately 230 people from one well.

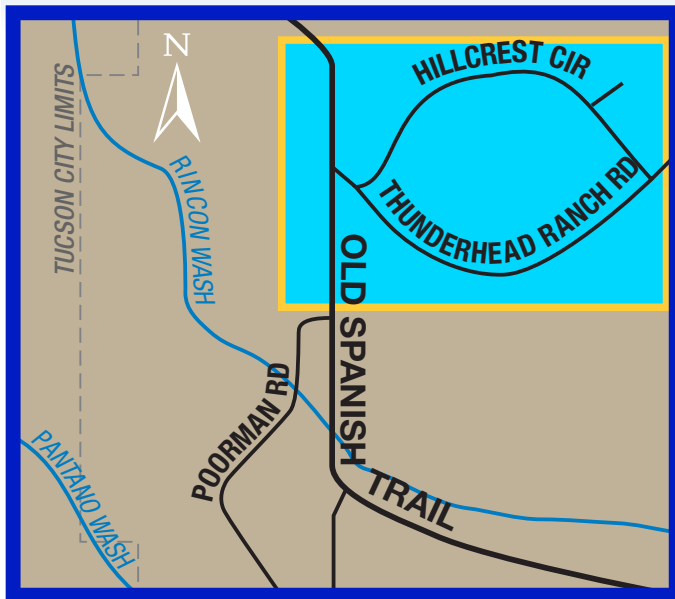
Thunderhead Ranch Water System

Thunderhead Ranch is a small subdivision west of Old Spanish Trail and about one and a half miles south of Irvington Road. It has about 57 connections supplying about 160 persons with water from two wells.

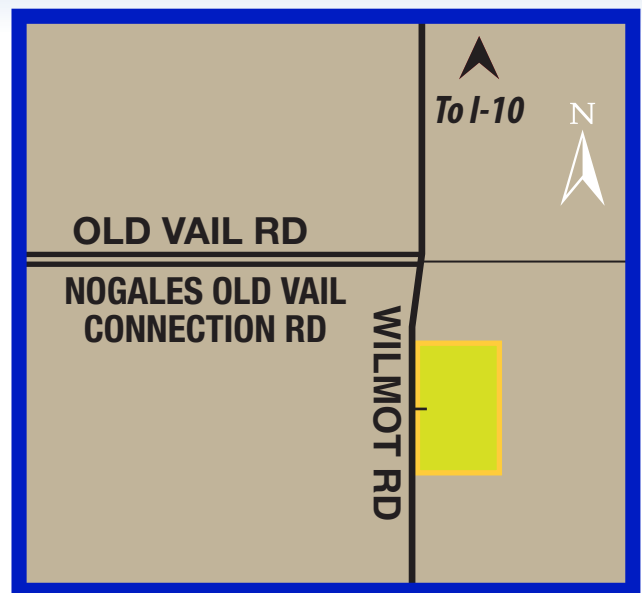
Tucson Police-Fire Academy Water System

The Police-Fire Academy, located south of Interstate 10 and east of Wilmot Road, was built in the late 1990s. One well supplies about 25 persons regularly, plus class members taught at this facility.

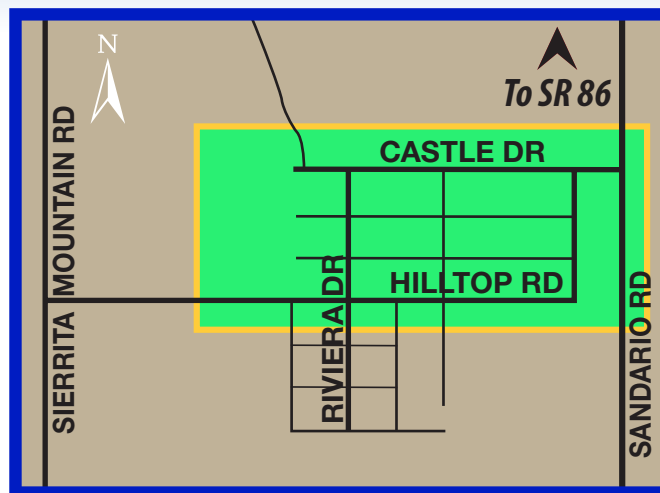
Valley View Acres Water System

Valley View Acres is a small community located north of Hilltop Road, just west of Sandario Road, with about 150 connections supplying about 470 people with water from two wells.
